**Electrolysis**  
in the  
**City of Winnipeg**

BY  
**L. A. HERDT, E.E., Ma.E.**  
Consulting Electrical Engineer

## ELECTROLYSIS IN THE CITY OF WINNIPEG.

In January, 1909, the writer was instructed by the Council of the City of Winnipeg to report upon the danger to the watermains and telephone cable system that might exist in the city, due to the return currents of the Winnipeg Street Railway Co., and to submit recommendations dealing with improvements of the present street railway system, so that electrolysis, if it existed, would be eliminated. A report was made following the above instructions, and was published in the *Canadian Engineer*, August 20th, 1909, *Canadian Electrical News*, September, 1909, and in other technical periodicals.

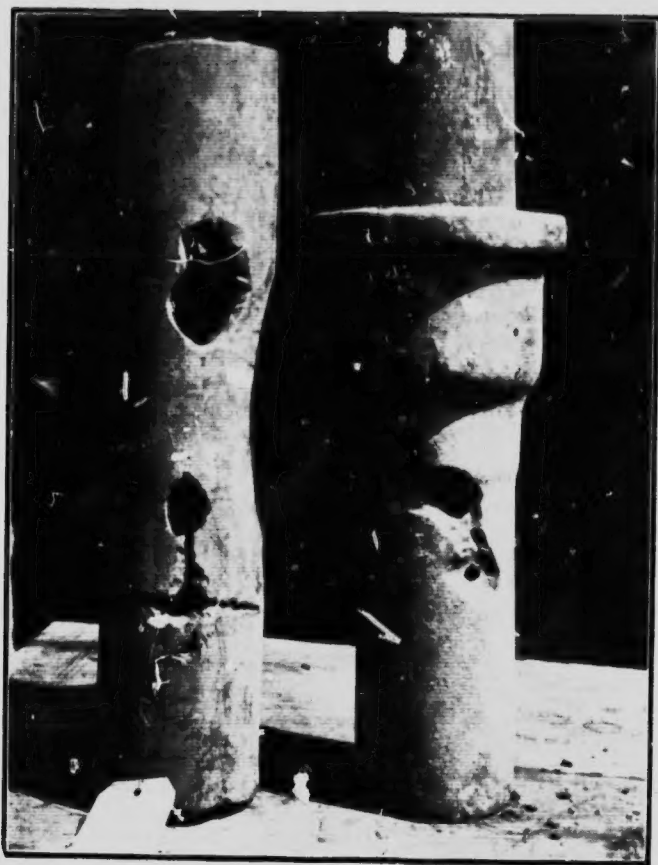
Fig. 1.  
Electrolytic Action on Water Mains.

Pieces of water pipe and lead covered cables taken from these districts by Mr. Cambridge were examined, and showed without doubt that holes and breaks in them had been caused by electrolytic action.

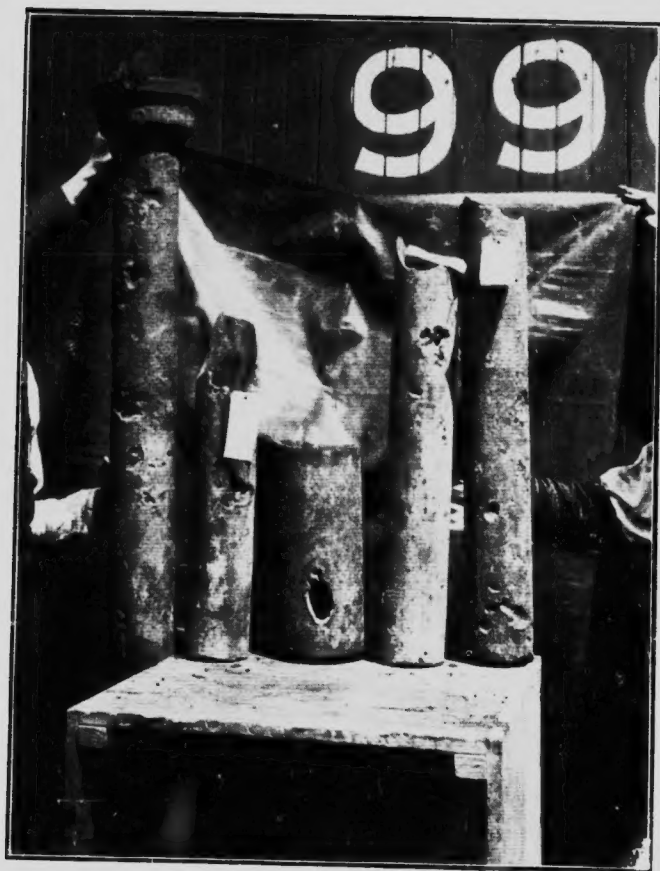
**Fig 2**

**Waterpipes Pitted and Burst on Account of Electrolysis.**
